Service Manual

8065752478 Rev. A, CATALOG NO.

Centurion® Vision System Service Manual
8065752478

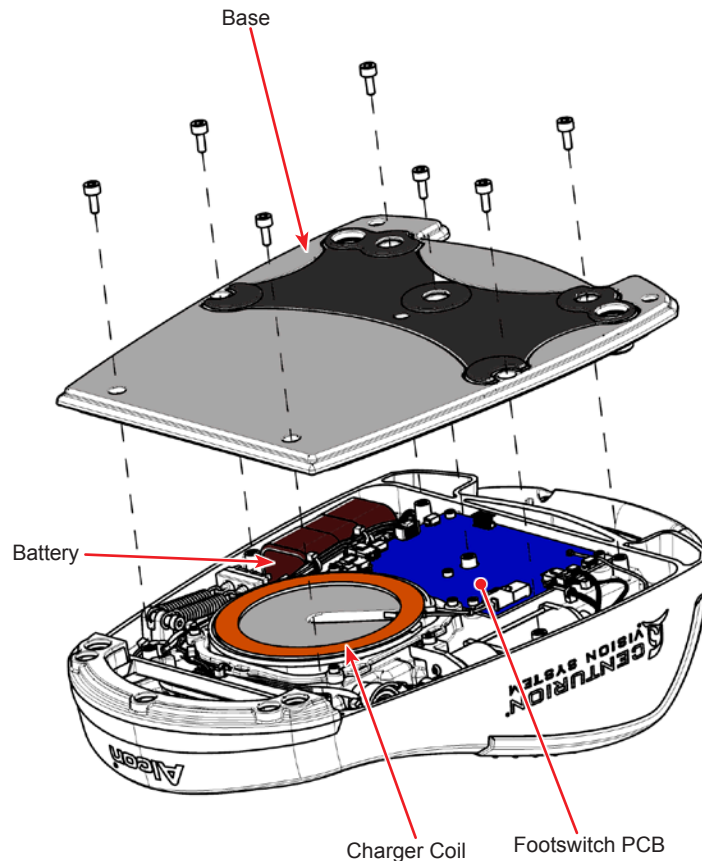
Figure 3-44 Footswitch Base Removal

- 42.1 Remove seven 4 mm hex screws securing Base to main housing (see Figure 3-44). Remove Base.

- 42.2 Disconnect Battery from J2 on Footswitch PCB. Remove Battery.

- 43.1 Remove seven 4 mm hex screws securing Base to main housing (see Figure 3-44). Remove Base.

- 44.1 Remove seven 4 mm hex screws securing Base to main housing (see Figure 3-44). Remove Base.

- 45.1 Remove seven 4 mm hex screws securing Base to main housing (see Figure 3-44). Remove Base.

- 46.1 Remove seven 4 mm hex screws securing Base to main housing (see Figure 3-44). Remove Base.

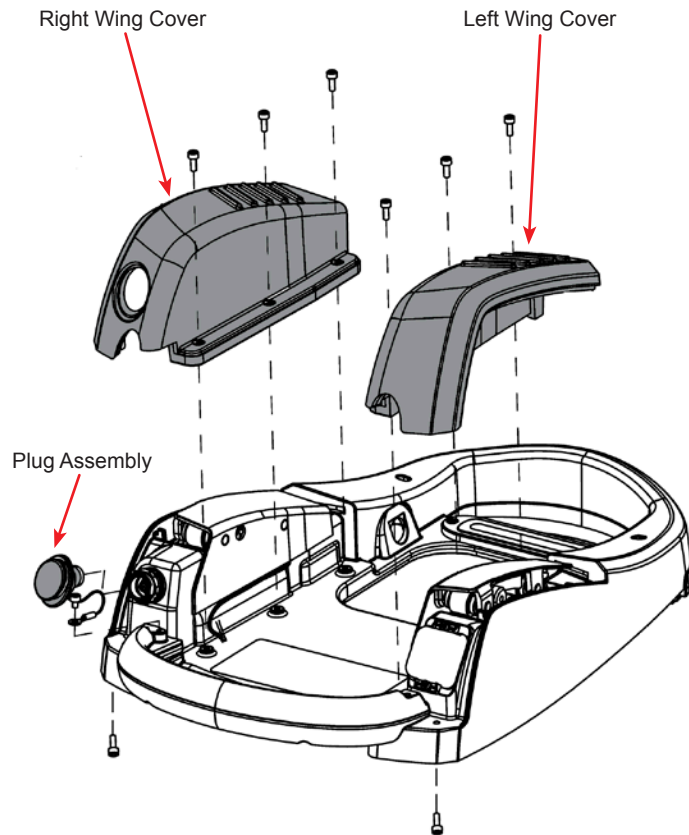
Figure 3-45 Footswitch Wing Covers and Connector Plug Assembly (shown without footpedal)

- 44.2 Remove Battery and Charger Coil as directed in previous steps. These items are not secured to the footswitch (connected to PCB) and will fall out when footswitch is turned over.
- 44.3 From underside of footswitch, remove one 2.5 mm hex screws securing Cover to main housing (see Figure 3-45).
- 44.4 Turn footswitch over and remove three 2.5 mm hex screws securing Cover to main housing.
- 44.5 Remove Cover from footswitch, repositioning as necessary to slide it forward until it clears the footpedal. If removing the Right Cover, feed the connector plug assembly through the hold in the Cover prior to sliding it along the footpedal.

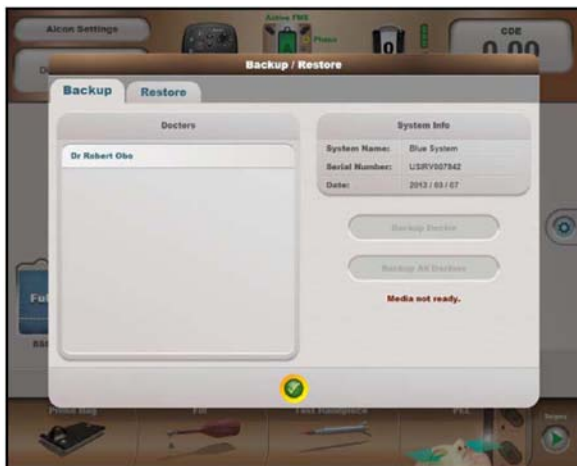
Figure 4-1 Backup/Restore Dialog Screen - Backup Tab

- 1.1.1 Plug a USB media into one of the rear I/O USB ports.
- 1.1.2 Select Backup/Restore from the Custom Menu. The Backup tab is the default as shown in Figure 4-1.
- 1.1.3 To backup an individual doctor: select *Doctor*, then press *Backup Doctor*.
- 1.1.4 To backup all Doctors: press *Backup All Doctors*.

- 1.2.1 Plug the USB media containing the Doctors Settings into one of the rear I/O USB ports.
- 1.2.2 Select Backup/Restore from the Custom Menu. The Backup tab is the default as shown in Figure 4-1.
- 1.2.3 Press the Restore Tab (see Figure 4-2).
- 1.2.4 To Restore an individual doctor:
 - 1.2.4.1 Press Doctors in the Sort By section.
 - 1.2.4.2 Press the Plus sign (+) next to the doctor's name.

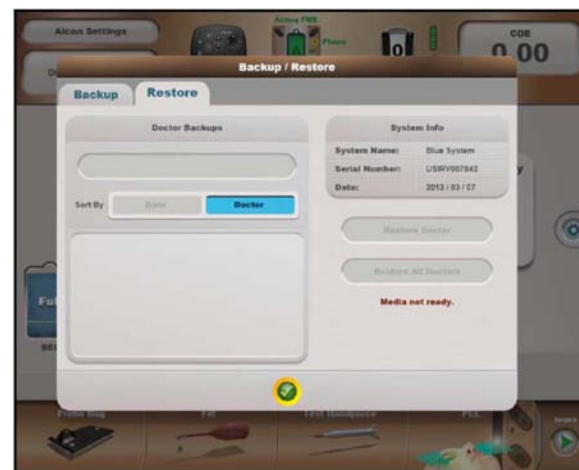
Figure 4-2 Backup/Restore Dialog Screen - Restore Tab

- 1.2.4.3 Select the date of the files to restore.
 - 1.2.4.4 Press the Restore Doctor button.
 - 1.2.4.5 Resolve any conflict by selecting Overwrite, Skip, or Save As.
- 1.2.5 To restore all Doctors:
- 1.2.5.1 Press Date in the Sort By section.
 - 1.2.5.2 Select the date to restore.
 - 1.2.5.3 Press the Restore All Doctors button.
 - 1.2.5.4 Resolve any conflict by selecting Overwrite, Overwrite All, Skip, Skip All or Save As.

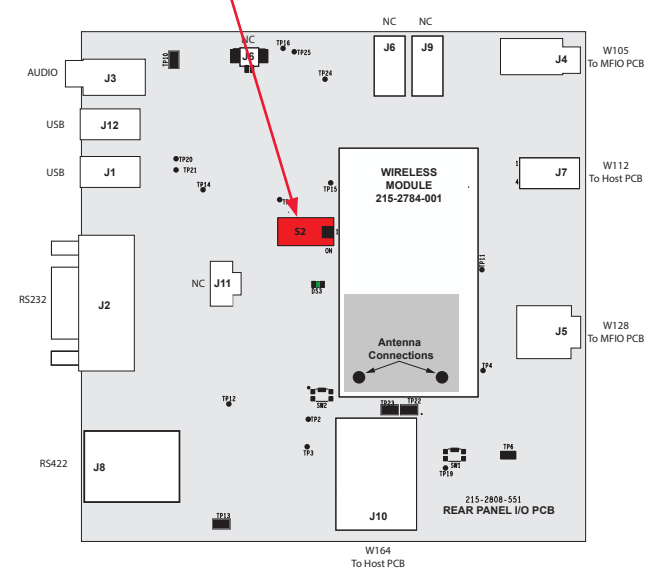
Figure 4-3 Wireless Network ON/OFF Switch

- 3.2.1 Remove Upper and Lower Rear Panels (see Section 3 for detailed instructions).
- 3.2.2 On Wireless Module-Rear IO PCB, move switch S2 into the off position to disable network wireless activity (see Figure 4-3 for switch location). **NOTE: LED DS3 illuminates green when Wi-Fi is on, and is not illuminated when Wi-Fi is off.**
- 3.2.3 Replace Upper and Lower Rear Panels.

Switch S2 - Wireless Network ON/OFF Switch

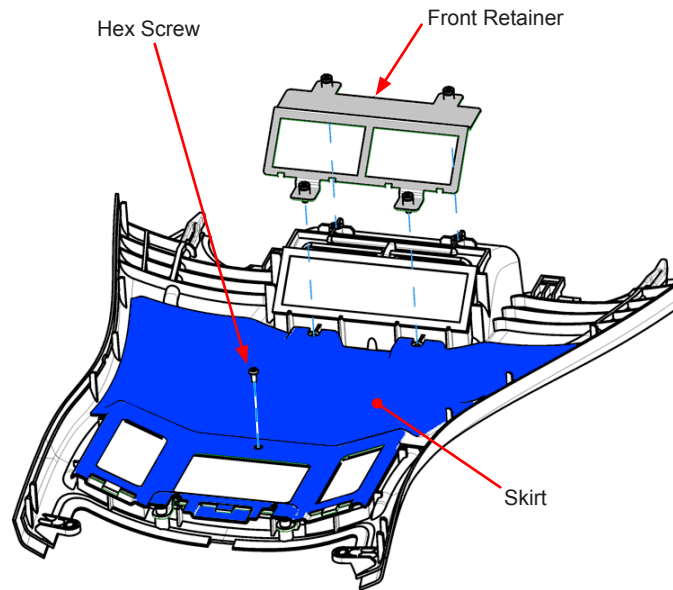
Figure 4-4 Lower Front Panel - Front Retainer and Skirt Removal

- 4.1 Remove the Lower Front Panel per Section Three of this manual.
- 4.2 Loosen four 3 mm captive screws securing the Front Retainer to the panel (see Figure 4-4). Remove Front Retainer and filter.

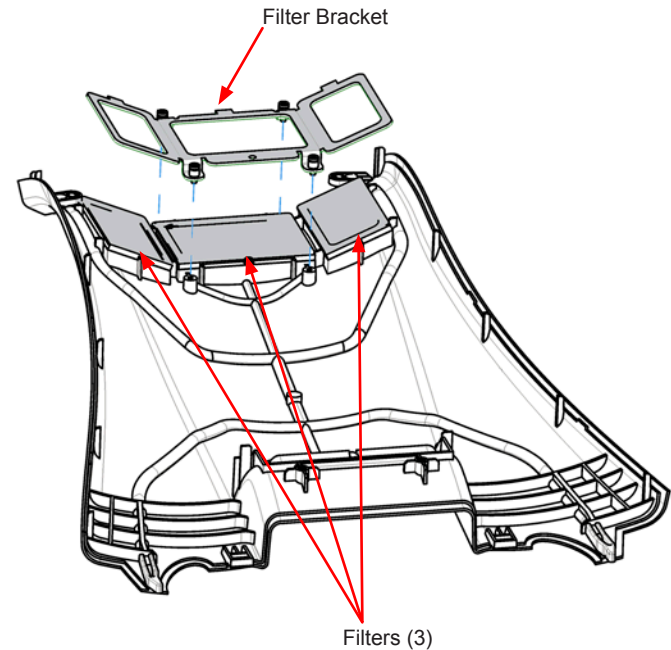
Figure 4-5 Lower Front Panel - Filter Bracket and Filter Removal

- 4.3 Remove 2.5 mm hex screw securing Skirt to Panel. Remove Skirt from Panel.
- 4.4 Loosen four 3 mm captive screws securing Filter Bracket to panel (see Figure 4-5). Remove Filter Bracket and three filters.

- 4.5 Clean four filters with water then shake dry.
- 4.6 Reassemble Front Panel assembly by performing this procedure in reverse order.

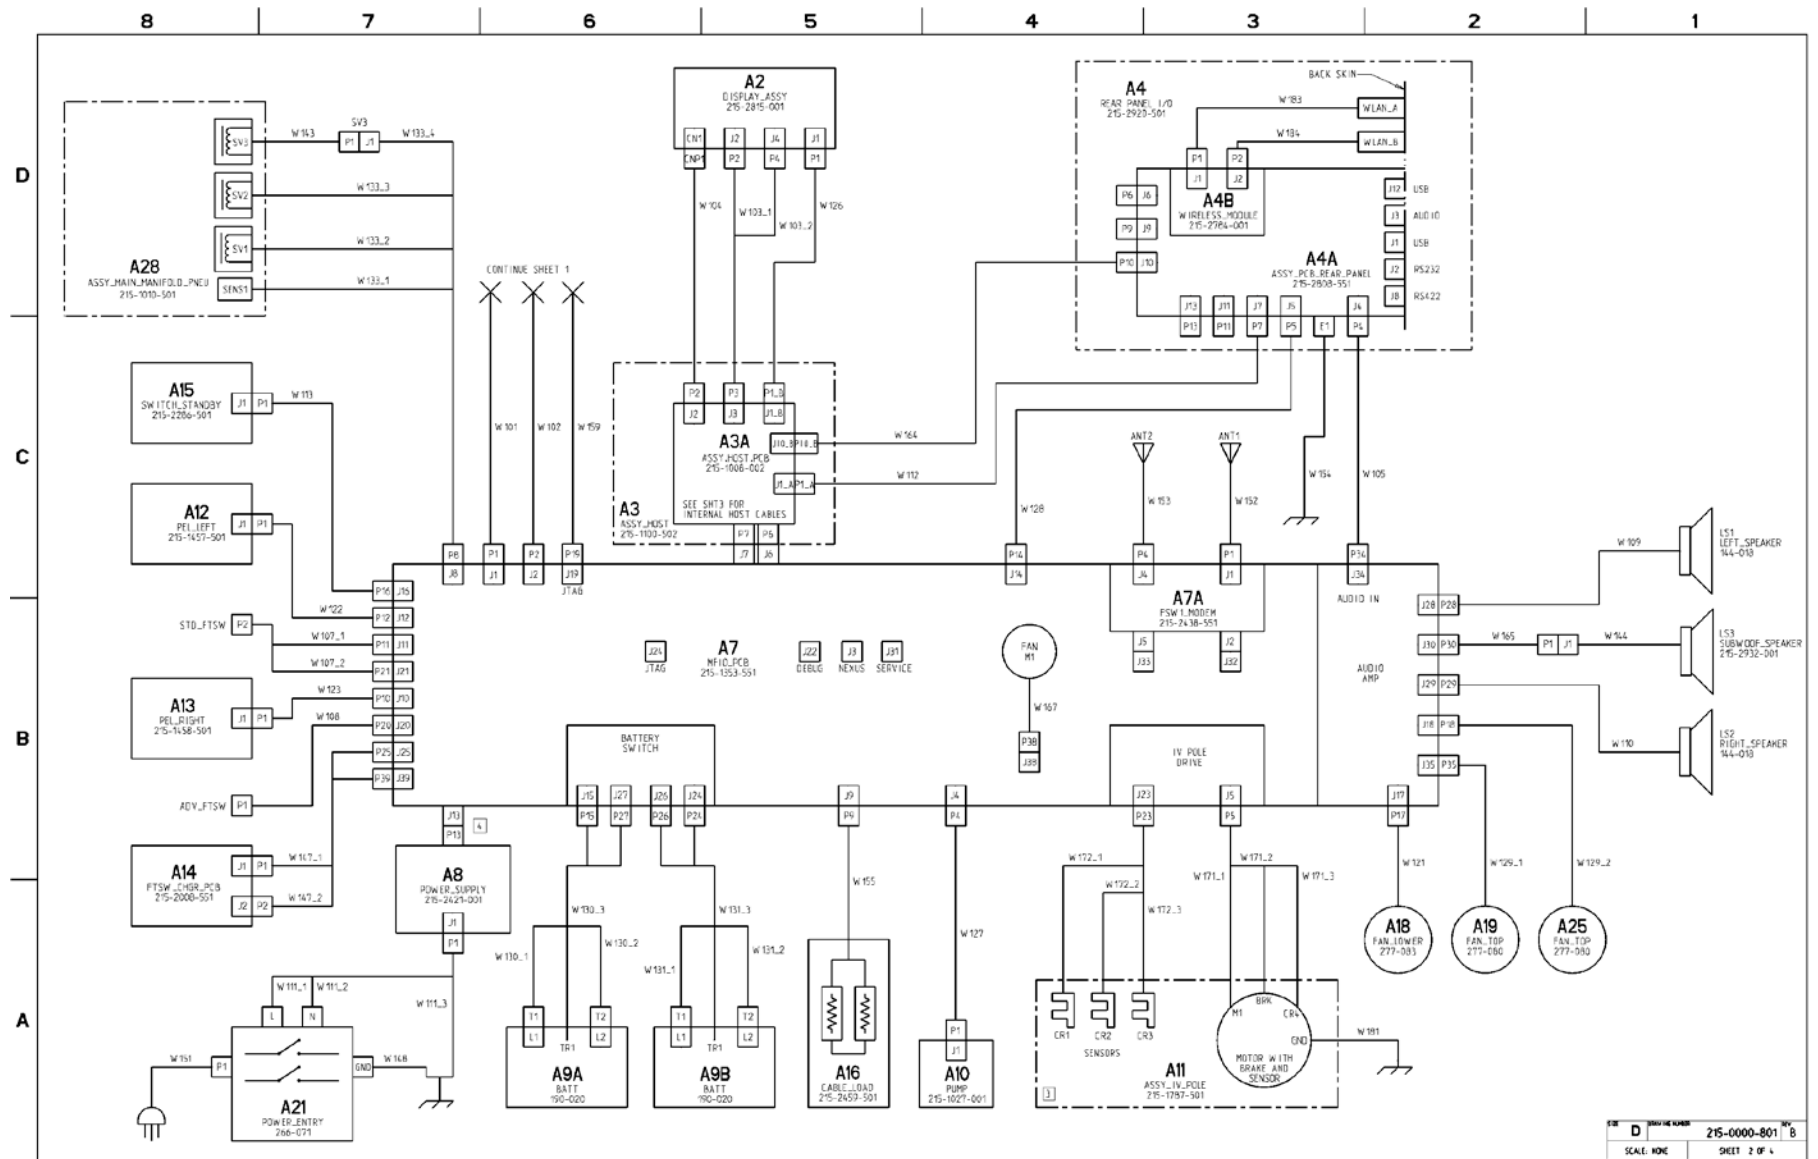
Figure 5-1 System Interconnect Diagram (sheet 2 of 4)

Figure 5-1 shows the system interconnect diagram for the *Centurion®* console.

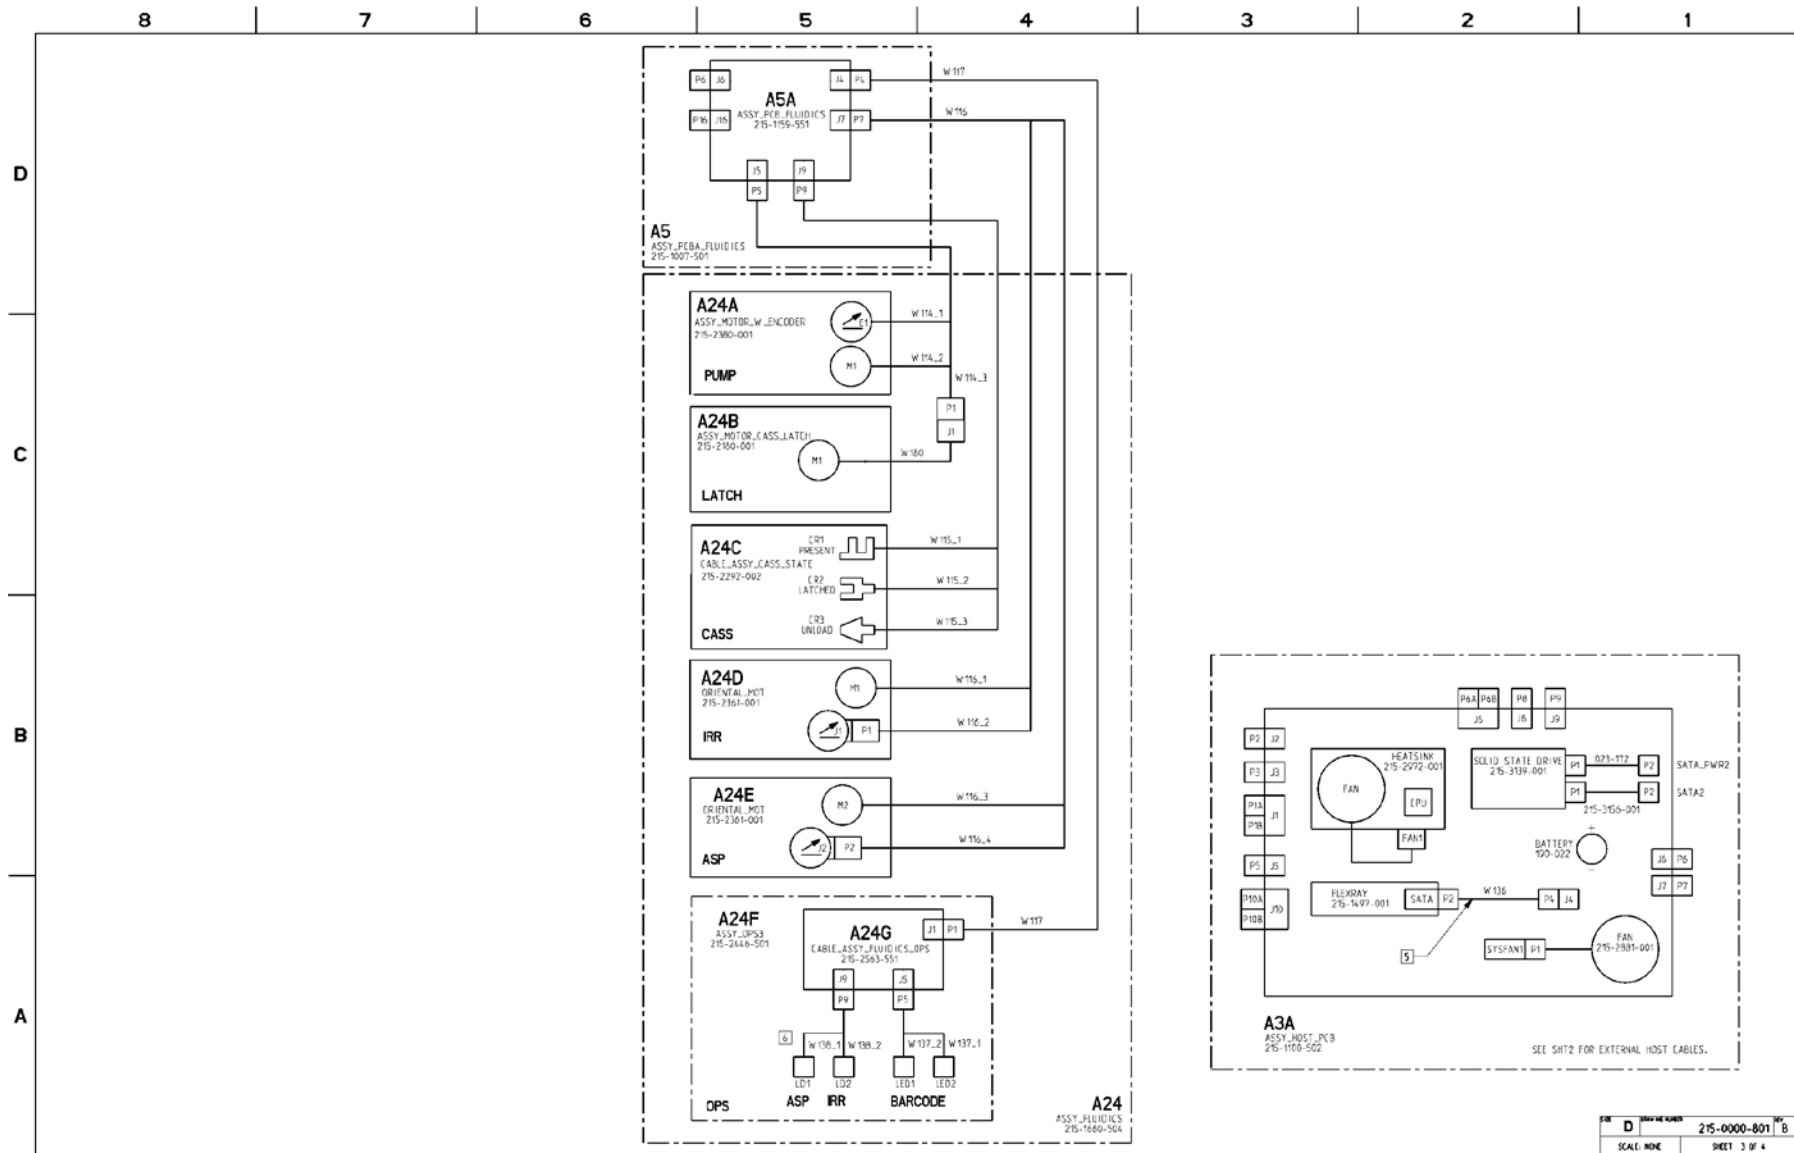
Figure 5-1 System Interconnect Diagram (sheet 3 of 4)

8	7	6	5	4	3	2	1
CABLES								
D	REF DES	ALCON PART NUMBER	CONNECTOR REF DES		DESCRIPTION	COMMENTS	REF DES	ALCON PART NUMBER
			FROM MODULE/CONNECTOR	TO MODULE/CONNECTOR				
	W101	215-1101-001	A1P4	A7P1	ASSY CABLE 24V PWR BK PLN W101		W108	215-1160-001
	W102	023-163	A1P3	A7P2	CABLE ASSY EXTERNAL DATA 24IN		W150	215-1150-001
	W103.1	215-1103-001	A1P3	A2P2	ASSY CABLE POWER DISPLAY W103		W151	023-139
	W103.2	215-1103-001	A1P3	A2P4	ASSY CABLE POWER DISPLAY W103		W152	023-144
	W104	215-1104-001	A2P1	A3P2	ASSY CABLE VIDEO DISPLAY W104		W153	023-144
	W105	215-1105-001	A7P3W	A4A1P4	CABLE ASSY AUDIO EXT W105		W154	215-2150-001
	W107.1	215-1107-001	STD_FTSW P2	A7P11	ASSY CABLE FTSW STD INTF W107		W155	215-2108-001
	W107.2	215-1107-001	STD_FTSW P2	A7P21	ASSY CABLE FTSW STD INTF W107		W159	023-131
	W108	215-1108-001	ADV_FTSW P1	A7P22	ASSY CABLE FTSW ADV INTF W108		W160	215-2176-001
	W109	215-1110-001	LS1LS1	A7P23	CABLE ASSY SPEAKER		W161.1	215-1145-001

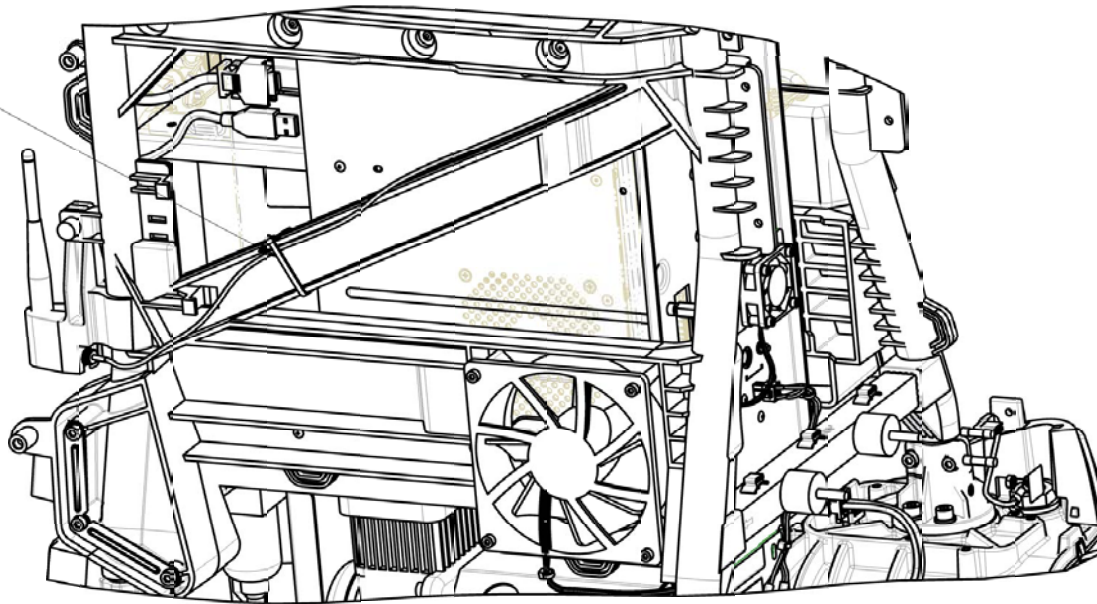
STEP 73

1. BUNDLE ANTENNA CABLE TO CHASSIS WITH TIE WRAP 027-009 IN IDENTIFIED LOCATION. TRIM EXCESS TIE WRAP.
REFERENCE CABLE ROUTING FILE 215-0000-501_PROC_CABLE.ASM, "R16" FOR DETAILS.
